ENGINEERING EXPERIMENT STATION
CIRCULAR SERIES No. 55

CONTRIBUTIONS TO PROCEEDINGS OF THE SECOND INTERNATIONAL CONFERENCE ON SOIL MECHANICS AND FOUNDATION ENGINEERING

I. A STUDY OF RETAINING WALL FAILURES

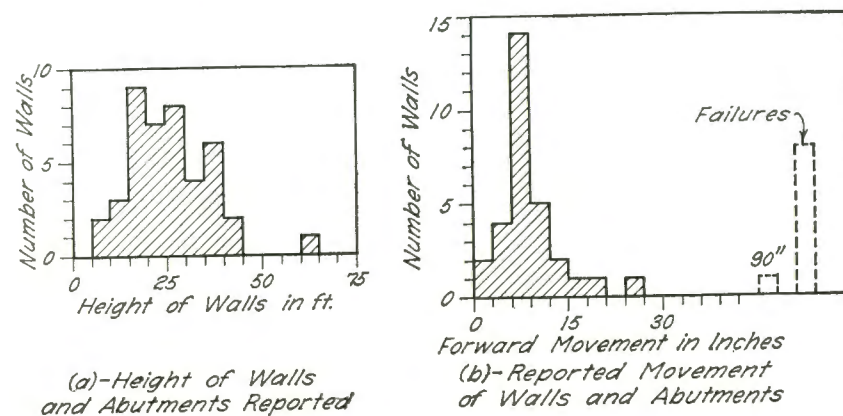
FIG. 2. CLASSIFICATION OF UNSATISFACTORY WALLS AND ABUTMENTS

The unsatisfactory walls and abutments are classified in Fig. 2a according to their height, and in Fig. 2b according to the magnitude of the movement they experienced. The majority experienced forward movements of 6 to 12 in. This is probably an indication that movements less than 6 in. are commonly not a matter of concern, and suggests that movements smaller than about 3 in. are usually considered quite normal and satisfactory.

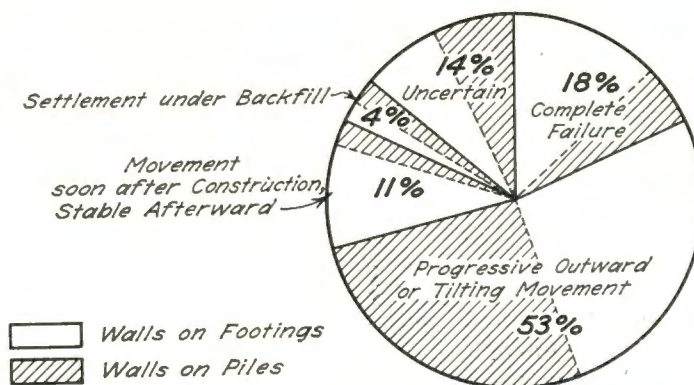
FIG. 3. CLASSIFICATION OF WALLS ACCORDING TO TYPE OF MOVEMENT

In Fig. 3 the walls are classified according to the type of movement they experienced. It may be observed that about 18 per cent failed completely. That is, they overturned, or broke structurally, or were considered in such imminent danger of collapse that they had to be

either strengthened or else removed and replaced. More than half the walls experienced a progressive outward or tilting movement.

Figure 3 also indicates that almost half of the unsatisfactory walls were supported on piles. This fact suggests that there was general recognition of unsatisfactory foundation conditions and that an attempt to improve the foundations was made by providing pile support. Nevertheless it does not appear that the mere use of piles, even including batter piles, sufficed to prevent excessive movement of the walls.

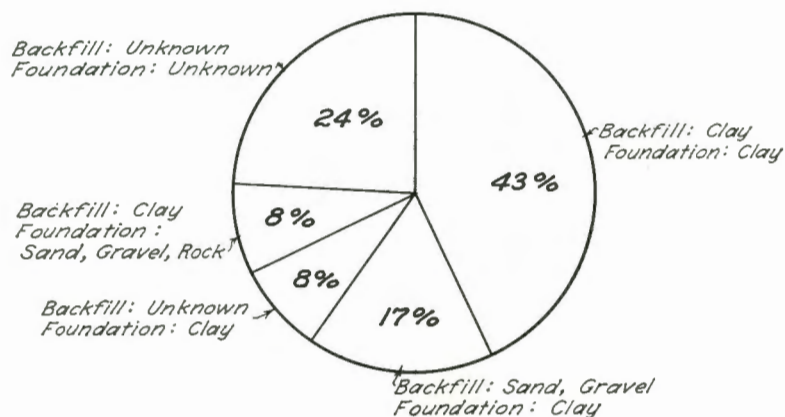
FIG. 4. FOUNDATION AND BACKFILL MATERIALS OF WALLS THAT EXPERIENCED PROGRESSIVE OUTWARD OR TILTING MOVEMENTS

Figure 4 shows the foundation and backfill materials associated with those walls that experienced progressive outward or tilting move-

ments. In every reported example of progressive movement where there was sufficient information to classify the soils, clay occurred in the foundation or in the backfill, and in most instances occurred in both. This suggests that present and past design procedures must be quite conservative when foundation conditions are good and when the backfill consists of sand or gravel. On the other hand, it also suggests that the factor of safety of walls founded on clay or backfilled with clay is probably on the average much lower than believed by the designers.

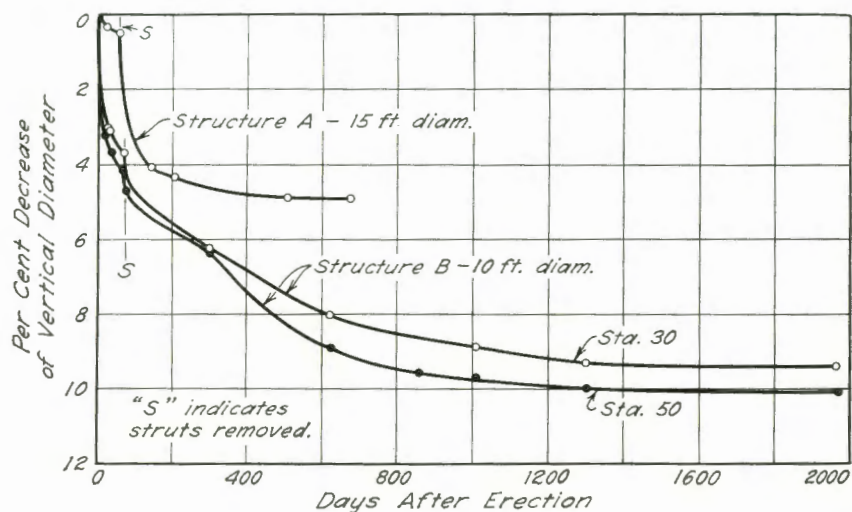
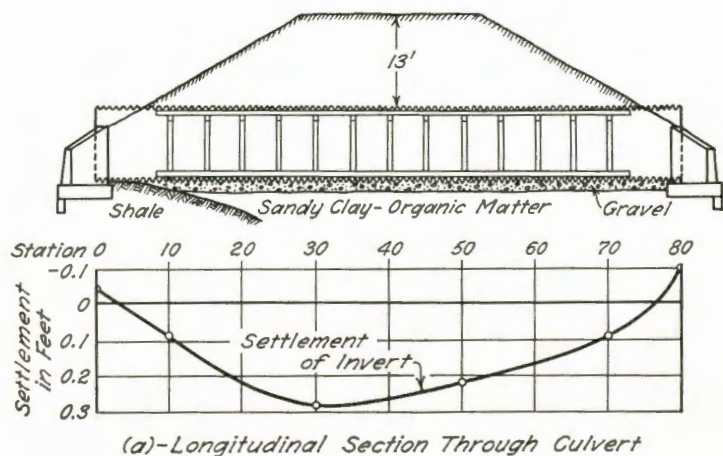
FIG. 2 (ABOVE). RELATION BETWEEN TIME AND SHORTENING OF VERTICAL DIAMETER
FIG. 3. SETTLEMENT OF THE CULVERT

The relation between time and the shortening of the vertical diameter of this culvert is shown in Fig. 2 by the curve marked Structure A. A small amount of crushing took place while the struts were still in position. At the time indicated by S, the struts were removed and the vertical diameter shortened rapidly for a few weeks. However, at the end of 200 days, movements had virtually ceased, and no appreciable movements could be observed after 500 days. The lengthening of the horizontal diameter was approximately equal to the shortening of the vertical diameter.

The decrease of the vertical diameter at Stations 30 and 50 near the middle of the culvert is shown in Fig. 2. It is observed that the percentage diameter change equals approximately twice that for Structure A and that about three years were required for the structure to reach equilibrium. Although the performance of this structure was not as satisfactory as that of any of the other culverts, the structure nevertheless developed no signs of failure and was entirely adequate for its purpose.

On account of the compressible material beneath the fill the base of the fill settled appreciably. The settlement of the invert of the culvert during the first three months is shown in Fig. 3a. The settlement placed the bottom of the culvert in axial tension. The only visible effects of the tension, however, were a few small cracks in the headwalls and a relative movement indicating that the upper part of the culvert was pulling out of the headwalls. At a similar site close to the location of the flexible culvert a concrete box culvert was established. It was subjected at the bottom to tension of the same nature as that experienced by the flexible culvert, and as a consequence developed a transverse crack across the invert and part way up the sides.

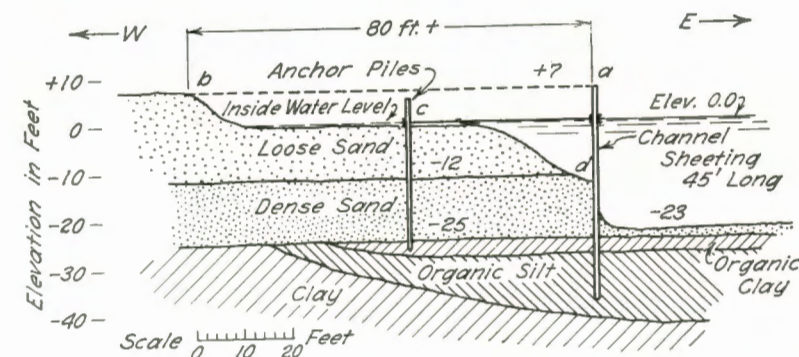
FIG. 1. CONDITIONS PRIOR TO THE SLIDE: CROSS-SECTION THROUGH DOCK WALL

Conditions prior to the slide are shown in Fig. 1, which represents a cross-section through the dock wall. The outer face of the dock consisted of sheet piles 45 ft long. To the east of the sheet-pile wall was a canal with its water level at El. 0.0. The channel was maintained by dredging to El. -23. On the west side of the sheet piling the surface of the ground had a constant level at El. +7. A row of anchor piles 30 ft long was driven vertically at a distance of 40 ft from the sheet piling and was tied to it by means of steel rods at water level.

The material between El. +7 and El. -12 consisted principally of loose sand deposited by means of a hydraulic dredge. Most of this fill was pumped out of the channel during the construction of the dock. Between El. -12 and El. -25 was a natural deposit of beach sand of the same grain size but of much greater relative density. At El. -25, the sand throughout this general area rests upon a bed of medium clay. At the location of the dock, however, part of the original surface of the clay had been once lowered by erosion and a fill of organic

material had accumulated before the beach sand was deposited. On account of the presence of the organic deposits as well as the inadequacy of the anchor piles, during the spring of 1945 the dock wall bulged toward the channel and showed signs of failure. As a consequence it was decided to reconstruct several hundred feet of the dock. In the reconstruction, longer piling was to be substituted for the original sheet piles and a new anchorage was to be built at a distance of about 80 ft west of the dock line.

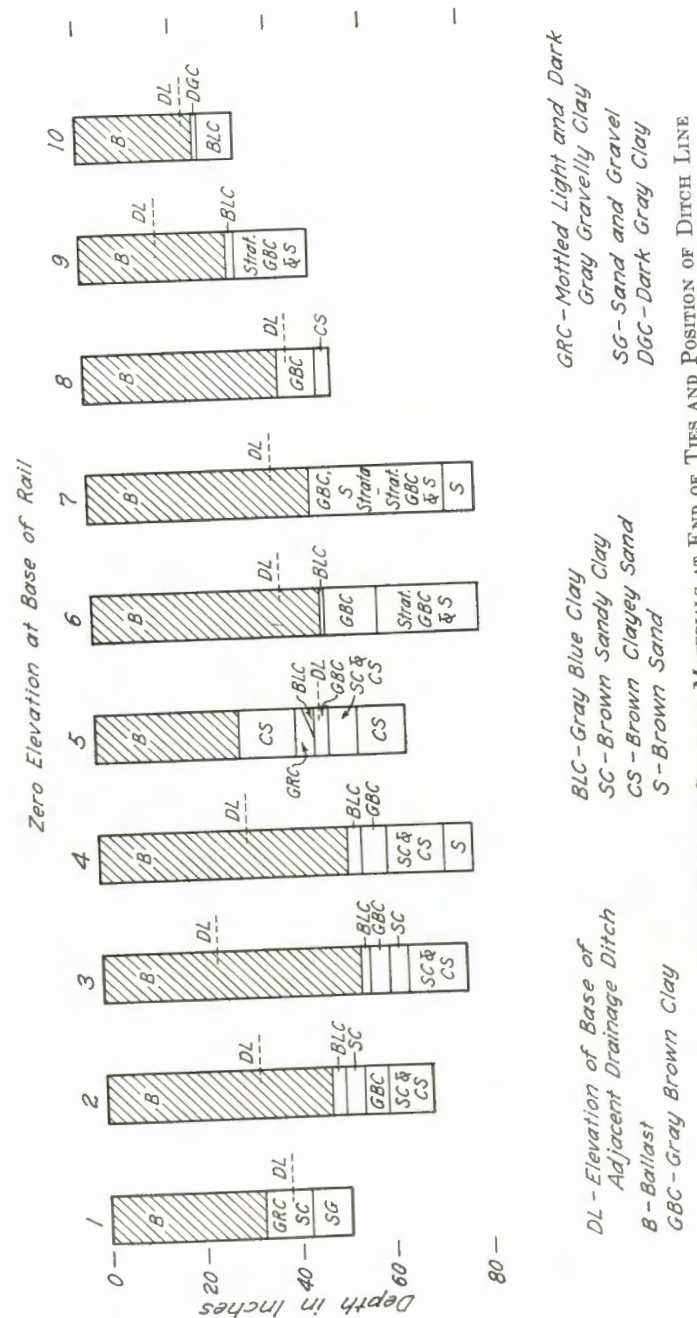
FIG. 1. DIAGRAM OF TRENCH SECTIONS SHOWING MATERIALS AT END OF TIES AND POSITION OF DITCH LINE

Figure 1, a diagram of each of the trench sections, indicates the

materials which were encountered at the end of the ties, and also the position of the ditch line with respect to the track structure. Table 1 contains the index properties of the plastic soils which were found. Table 2, page 48, indicates the condition of the roadbed as classified by the track foreman, and the position of the ditch line with respect to the top of the subgrade.
